Saddle Fit Thermal Imaging Report McKiernan

PATIENT: McKiernan **THERMOGRAPHY DATE:** 01.28.14 **TIME:** 11:15 AM

INTERPRETATION TYPE: Saddle Fit Evaluation

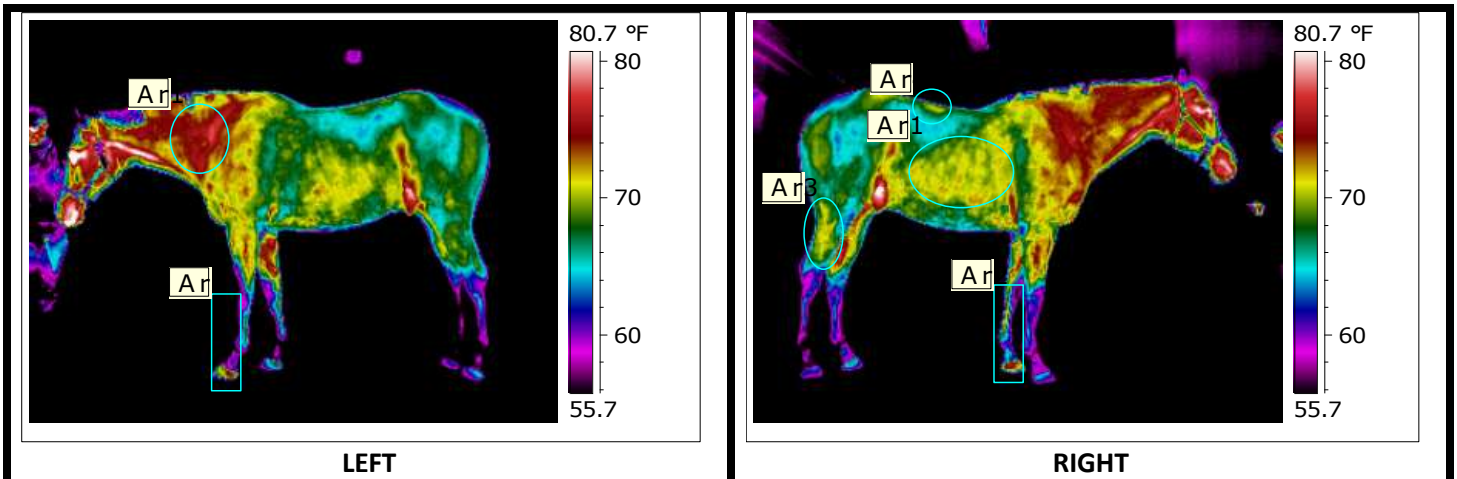
BEFORE EXERCISE

Some asymmetry seen on lateral views. There is increased heat in the left front foot and along the soft tissue of the lower limb. There is increased heat along the neck, particularly at the shoulder tie-in, greater on the left. The right gaskin has greater heat than the left indicating possible primary inflammation or muscle imbalance. Further details are included in the evaluation of the full scan. There is greater heat along the right rib area indicating muscular imbalances. There is also an area of increased heat on the right at the thoracolumbar spine which may be due to chiropractic lesions or saddle fit issues.

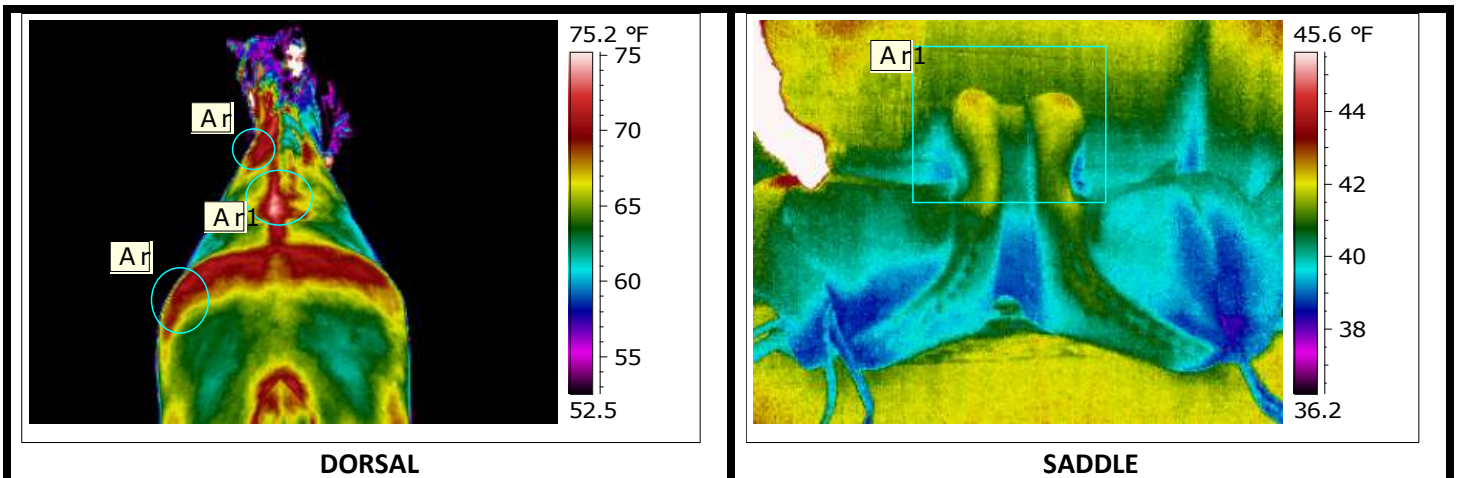
Increased heat withers and thoracolumbar spine with extension into the right paraspinal area. Increased heat left withers/shoulder. Right side of withers obscured by mane. Chiropractic lesions and/or saddle fit issues likely. Palpation and saddle fit analysis recommended. Increased heat left gluteals. The saddle shows uneven pressure/flocking of the rear part of the panels. The gullet channel seems to narrow (dovetail) at the rear. The sweat flap shows heat transference from person's hand.

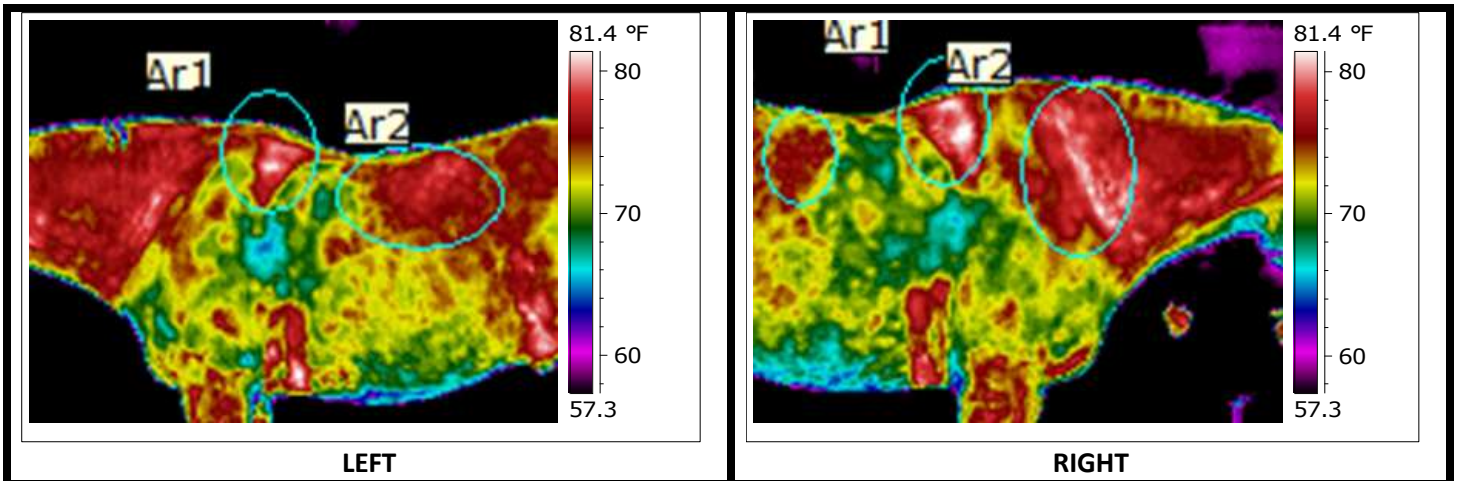
AFTER EXERCISE

Increased heat at the withers and shoulder, greater on the right. There is also increased heat along the paraspinal muscles and ribs both sides, greater on the left indicating uneven pressure from the saddle or imbalances in the horse or rider.

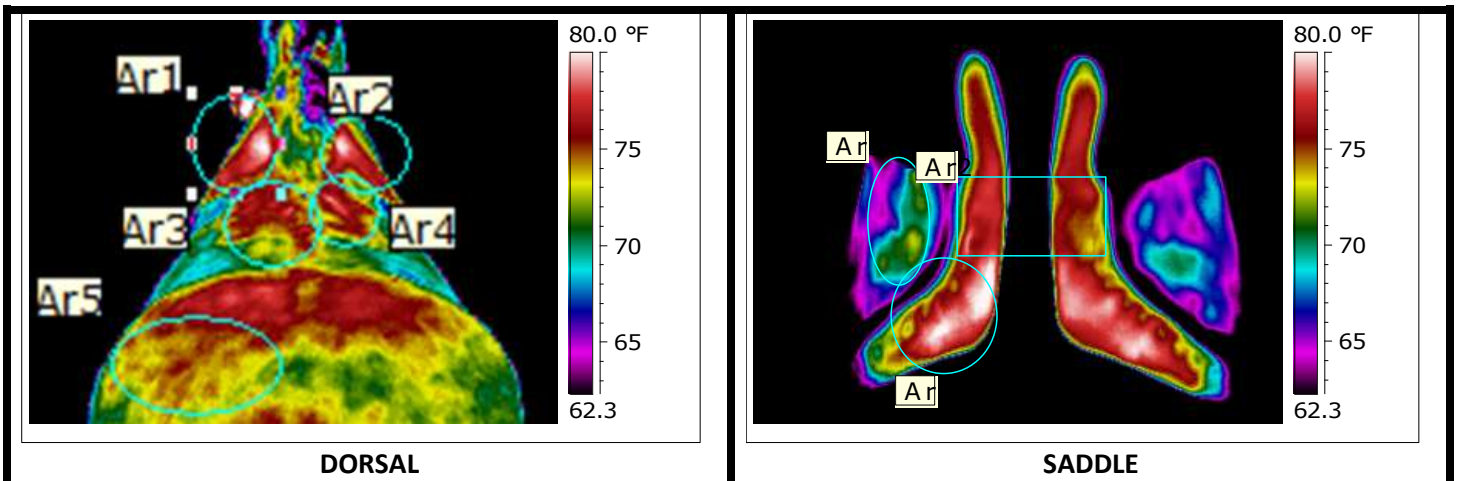
There is increased heat at the withers and thoracolumbar spine, greater on the left. Also some asymmetry in the gluteal muscles, greater on the left. The saddle shows uneven pressure all along the panels as well as the flaps. Pressure appears greater on the left indicating uneven contact. The rear of the panels also appears to have limited contact creating increased pressure.

SUMMARY AND RECOMMENDATIONS: This saddle does not fit McKiernan. There is increased pressure at the withers indicating the saddle is too narrow. It also appears to be placed a bit too far forward. The rear of the panels has limited contact creating increased pressure and indicating the channel is too narrow and the panels are perched and/or flocking is uneven. Bridging is also present creating increased pressure at the front and rear of the panels and is another indication of a too narrow saddle. The uneven pressure along the front of the panels may indicate uneven flocking or uneven shoulder development. The uneven pressure in the flaps may indicate horse or rider imbalances.

McKieran needs a different saddle, one which is wider and conforms better to his conformation. As McKieran is brought further into work and his body changes it would be easier to make adjustments with an Adapatree saddle (www.saddlefit4life.com). More information about saddle fit can also be found at www.Schleese.com.

A full veterinary chiropractic evaluation is also highly recommended to further evaluate the inflammation seen in the spine.
