Blue Wave Infrared
Equine Thermal Imaging

Thermal Imaging Report

PATIENT: AJ

THERMOGRAPHY DATE: September 18, 2013

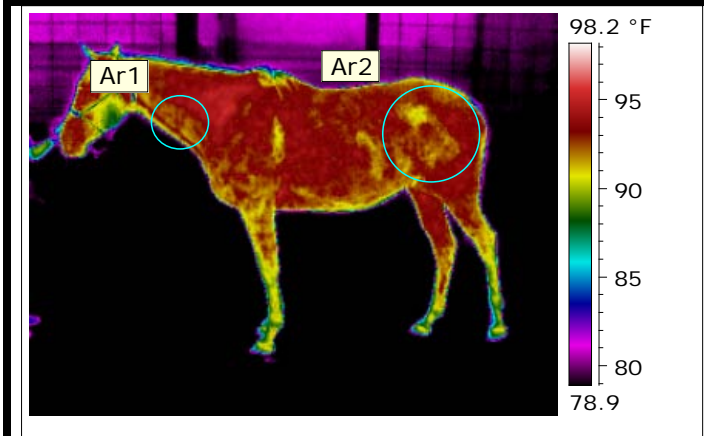
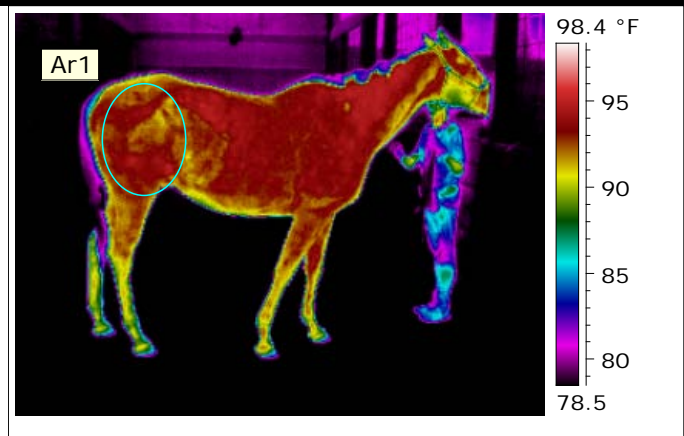
Whole horse lateral views are generally symmetrical; tension lines through the hindquarters suggesting strain, and small increase at the left neck.

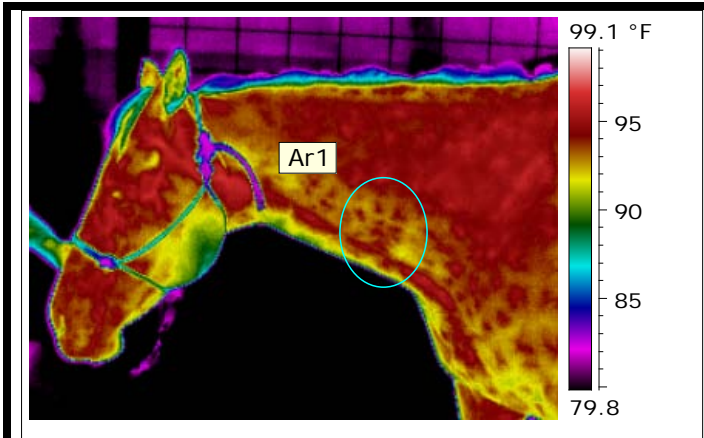
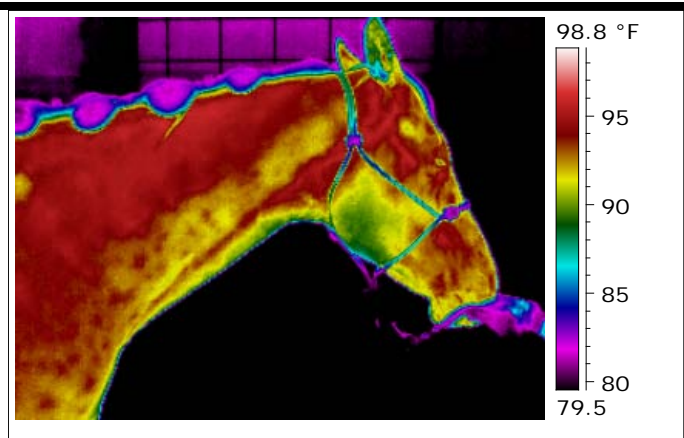
Slight increase at the left C4 region, palpation is warranted, assess range of motion; could be chiropractic, muscular, or facet changes.

The left neck shows a subtle band around C4 which could be local irritation, chiropractic change, or other inflammation. Palpation would be useful.

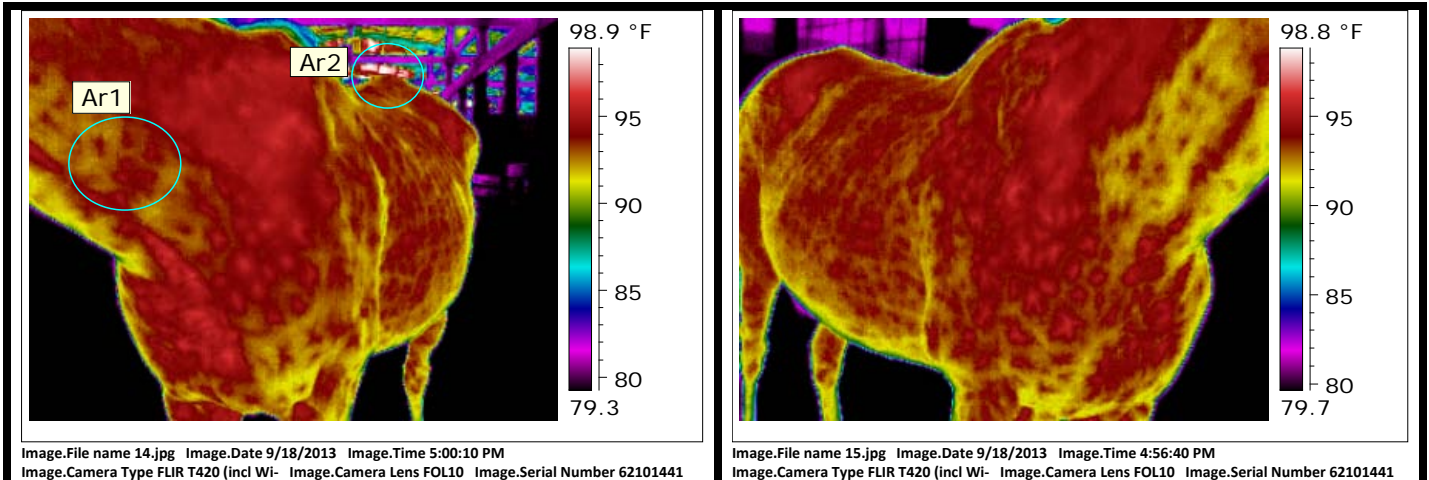
Left neck again increased. Early suggestion of tarsitis in these views. Grossly peaked sacrum suggesting SI strain.

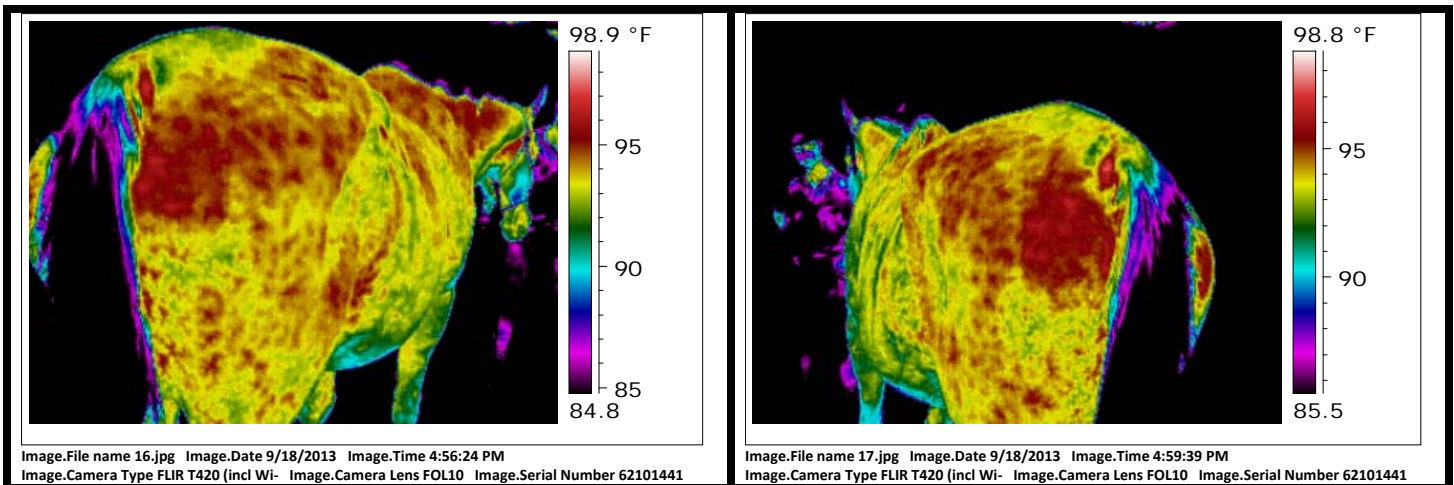
Patient is boney at the haunches with evidence of muscular stress, hence increased heat is present over the tuber ischiaie bilaterally. Lack of roundness and development in the haunches dictates the patient is not using himself correctly behind, whether secondary to his lameness, or saddlefit/riding issues.

AJ shows a lack of hindquarter development, with tension in the haunch muscle patterning and a lumbo-sacral dip and prominent tuber sacrale. These changes suggest he does not use himself correctly behind, which could be secondary to pain/lameness, or related to saddle-fit or training issues. Careful palpation is required of the hindquarters, and the hips and stifles. Based on the patterning and a lack of a t-zone from hips to tail head, palpation and ultrasound of the SI and low lumbar regions might be useful, as well as supportive care such as veterinary-chiropractic and veterinary-acupuncture.

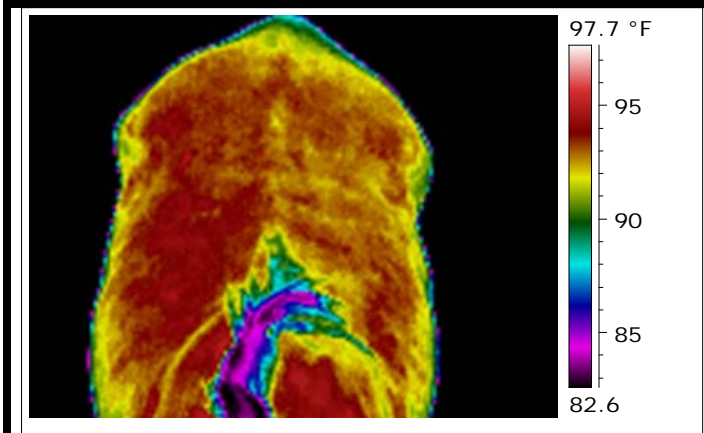
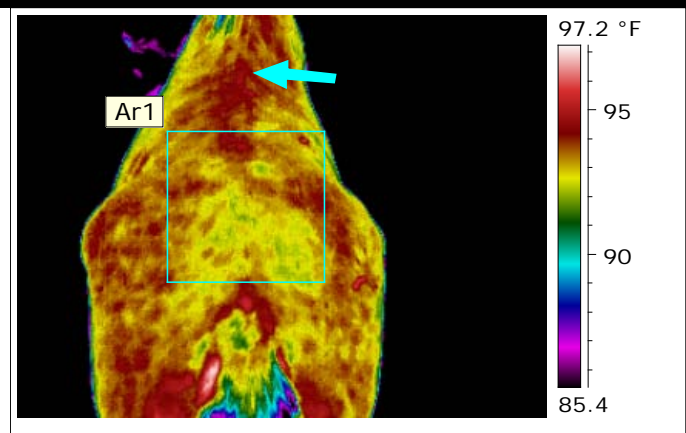
Lack of a t-zone between the hips and the tail head suggests chronic sacral issues, ultrasound would be useful to assess for pathology, along with supportive modalities such as chiropractic and acupuncture. Patterning in the back suggests possible kissing spine (perpendicular streaking) and/or saddle-fit issues; palpation is warranted, with a saddle-fit check, and radiographs if needed.

There is patterning in the topline suggesting saddle-fit issues or other focal inflammation, with suspicion for kissing spine at the marked area, though radiographs are only warranted if there is a history of pain or reactivity, especially when being saddled.

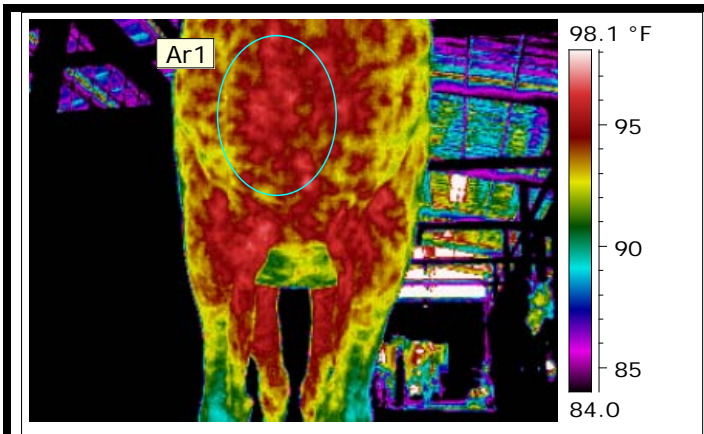
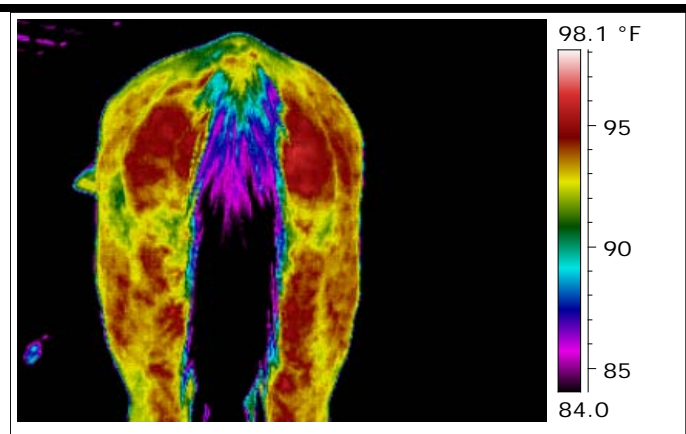
Slightly increased at the pectorals, more on the right side, often seen with primary strain or compensation for sore feet. Tuber ischiae heat previously noted; hamstrings generally symmetrical; sacral issues likely in this patient.

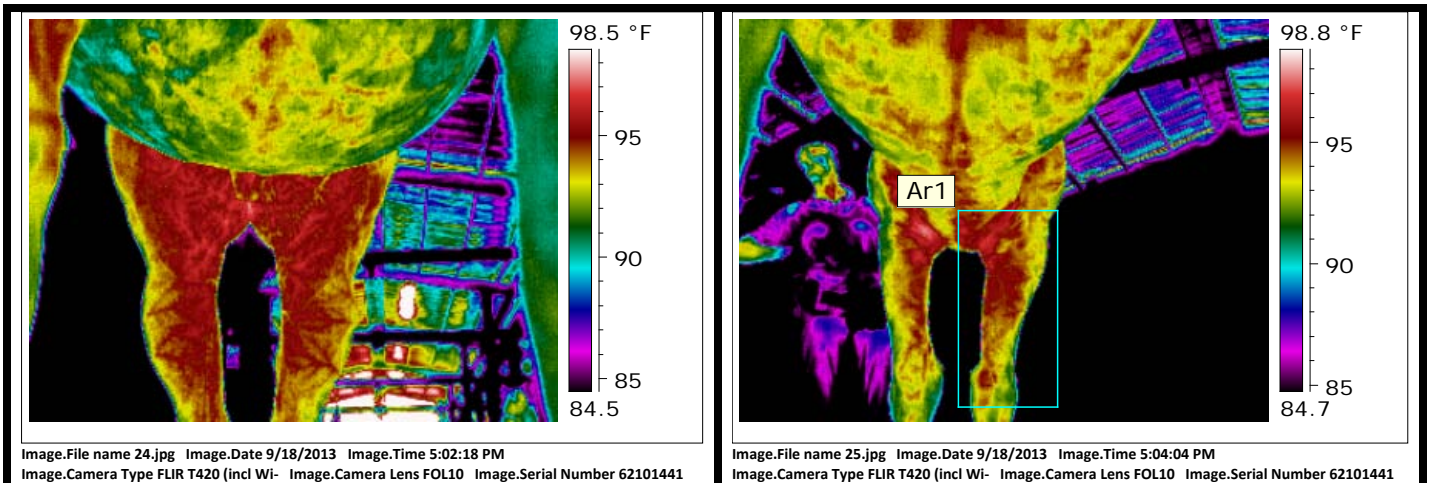
Cannot see the hocks in this view; gaskins are generally symmetrical; slight increase RF at the flexors.

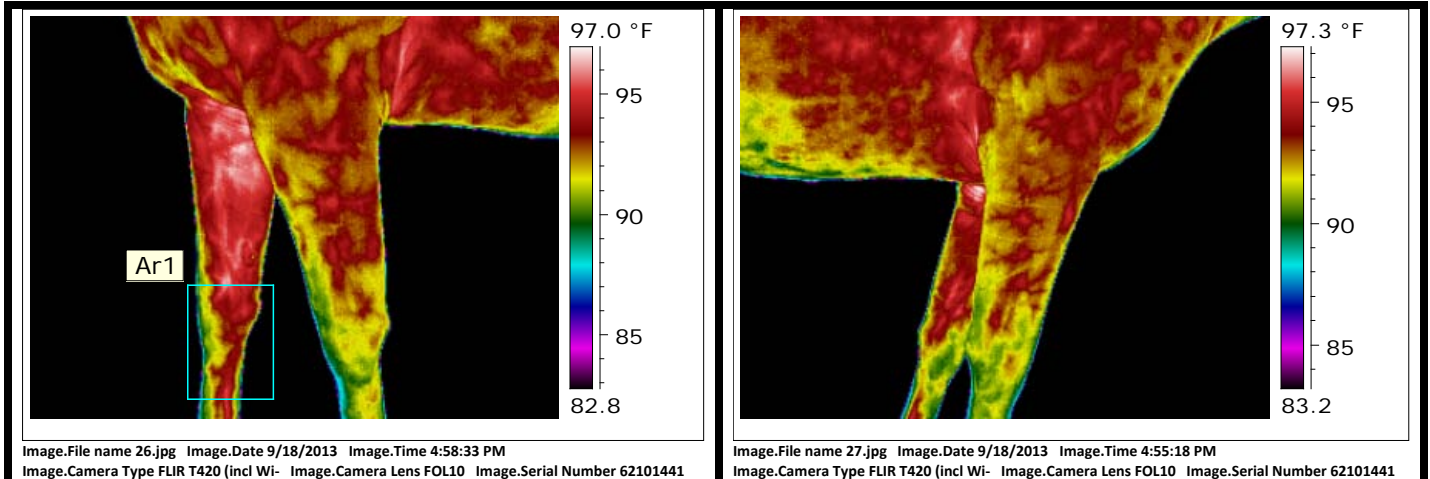
Increased heat at the RF flexors, could be primary or compensatory and requires further assessment.

The RF shows increased heat throughout the flexors and palpation is warranted, with ultrasound as a baseline if there is reactivity noted. Strain is likely, and could be off-loading from the hind end.

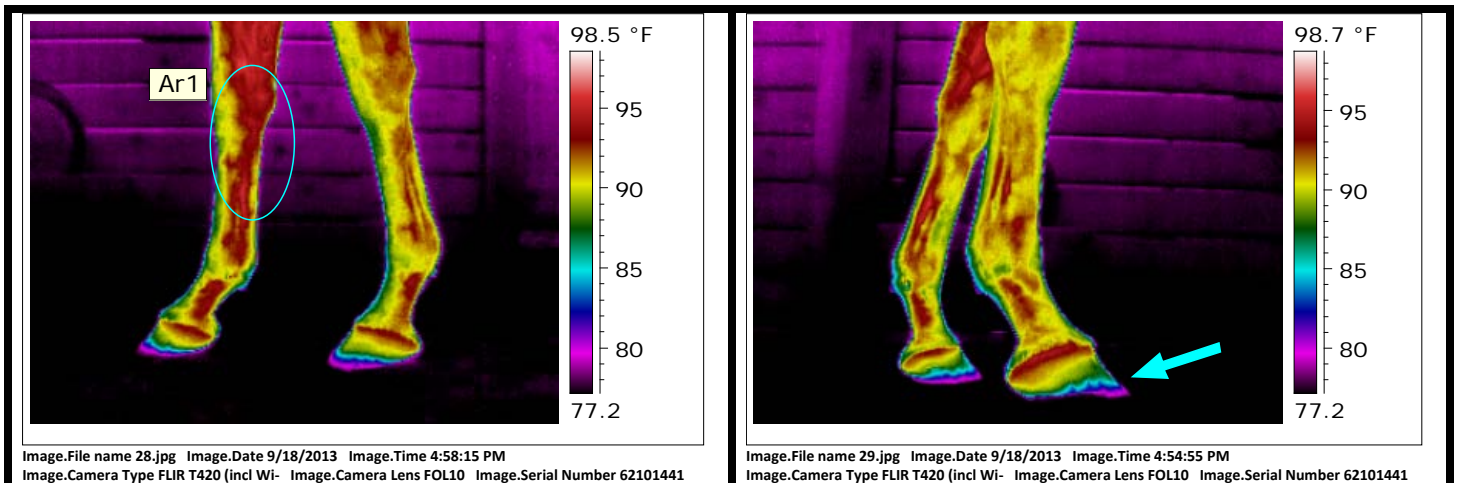
General increase throughout the RF, some dishing at hoof wall with evidence of longer toe, might be able to pull break over back and better support the boney column (radiographs would be needed to determine sole depth, wall thickness, and alignment of the boney column). Palpation of RF soft-tissue for strain would be useful.

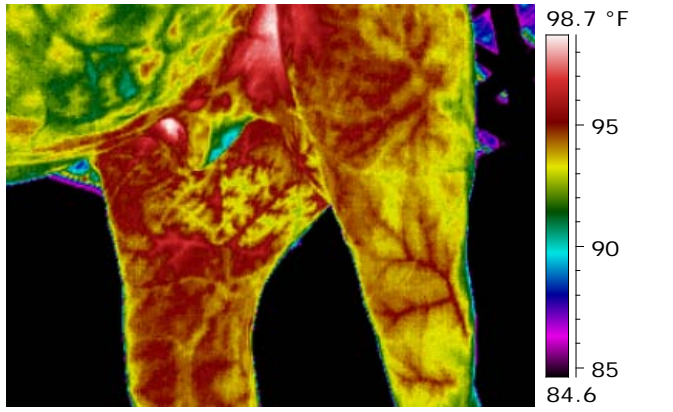
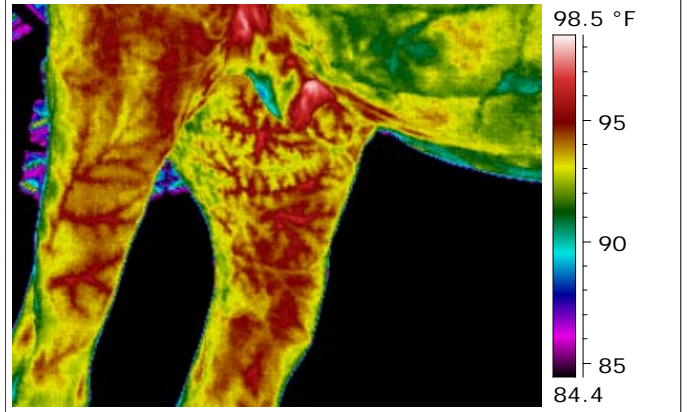
NSF: No Significant Findings

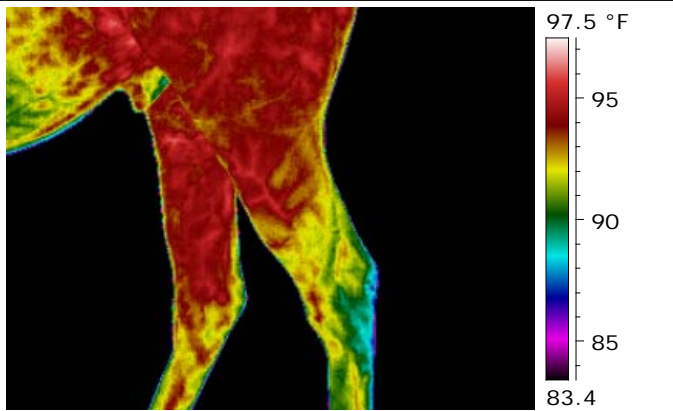
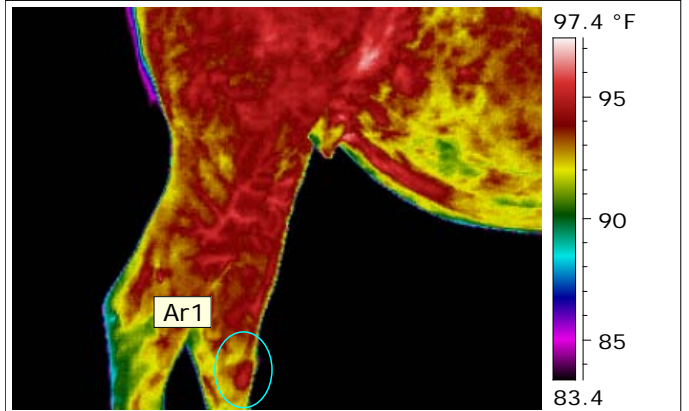
Check for scrape or other inflammation medial LH hock. Gaskins symmetrical.

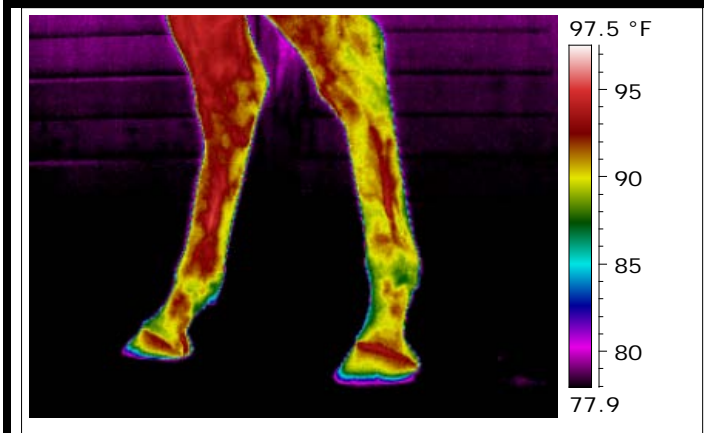
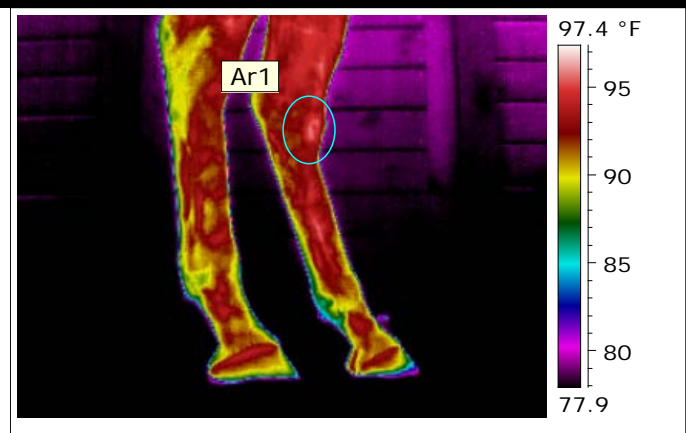
Check for source of increased heat at medial LH; tarsitis is suspected bilaterally. Patterning in these views is generally symmetrical, and the coronary bands are not overtly abnormal, though with diffuse heat at both walls suggesting thin walls, stress, or infection, at the feet.

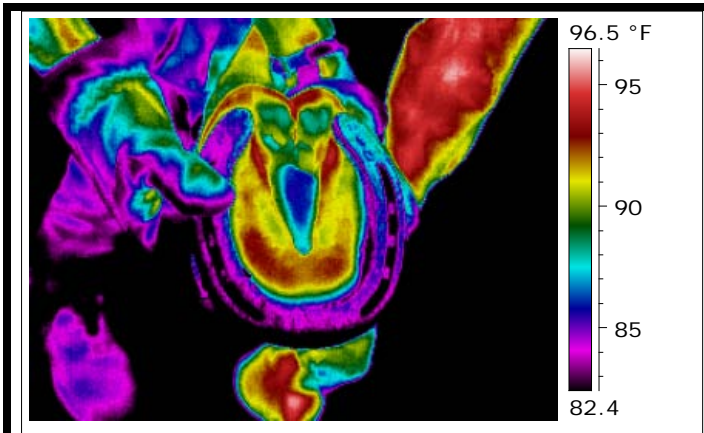
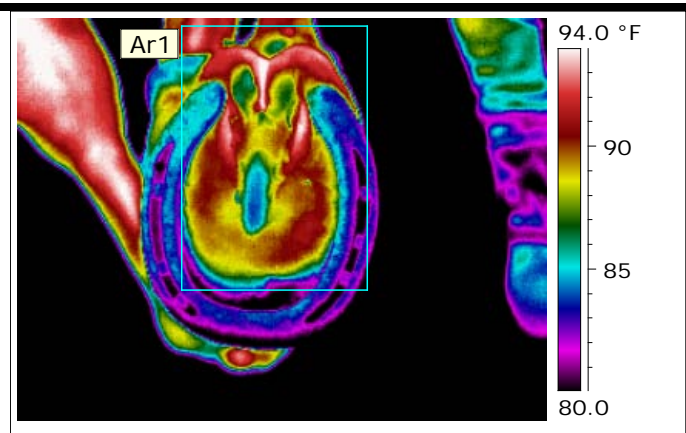
Patterning at the feet shows increased heat t the soles and heels, with likely thin sole, especially RF, flattened heels and a lack of support. Cooler area at the RF toe could be debris or indicate long toe/separation.

All four hooves show abnormal patterning, and certainly the low-heel thin sole problems are common in Thoroughbreds, but he appears to lack support and baseline radiographs of the hooves would be useful to assess sole depth, wall thickness, and boney column alignment. The RH shows a significant increase in sole heat at the toe portion, suggesting an active bruise or developing abscess; coffin fracture or hot nail could also produce this patterning. Local assessment with hoof testers, radiograph, soaking, anti-inflammatories, etc. are recommended.

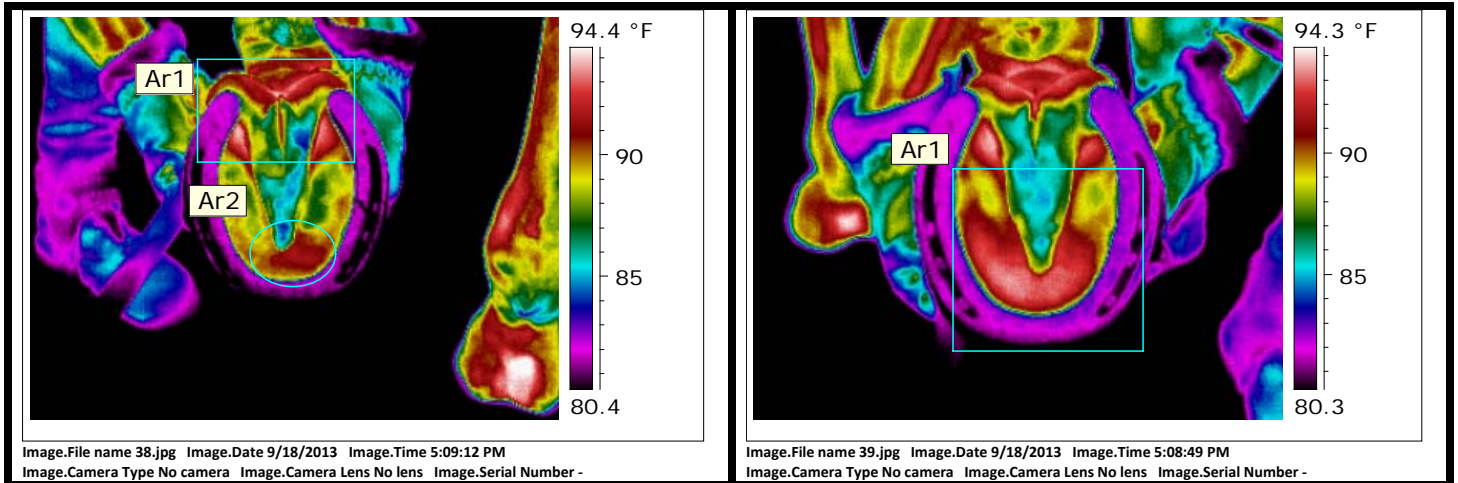
As above, both hinds show increased heat at the heels and toes, especially the RH, which would support the patient's history and indicate significant bruising or other developing abscess/infection, coffin fracture, or hot nail. Assessing with hoof testers, radiographing the foot, and soaking/local treatment, are recommended. The excessive heat can be seen in the standing portion of the RH in the left image.
