Saddle Fit Thermal Imaging Report McKiernan

PATIENT: McKiernan **THERMOGRAPHY DATE:** 01.28.14 **TIME:** 11:15 AM

INTERPRETATION TYPE: Saddle Fit Evaluation

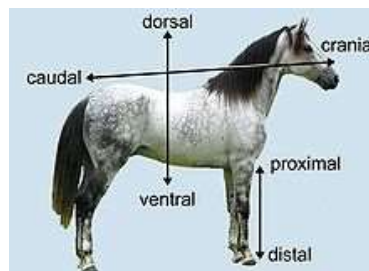
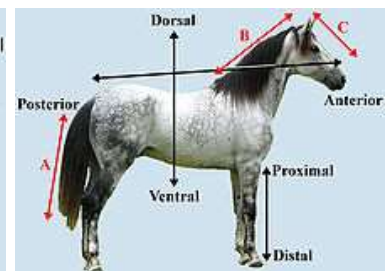
BEFORE EXERCISE

Increased heat withers and thoracolumbar spine with extension into the right paraspinal area. Increased heat left withers/shoulder. Right side of withers obscured by mane. Chiropractic lesions and/or saddle fit issues likely. Palpation and saddle fit analysis recommended. Increased heat left gluteals. The saddle shows uneven pressure/flocking of the rear part of the panels. The gullet channel seems to narrow (dovetail) at the rear. The sweat flap shows heat transference from person's hand.

SUMMARY AND RECOMMENDATIONS: This saddle does not fit McKiernan. There is increased pressure at the withers indicating the saddle is too narrow. It also appears to be placed a bit too far forward. The rear of the panels has limited contact creating increased pressure and indicating the channel is too narrow and the panels are perched and/or flocking is uneven. Bridging is also present creating increased pressure at the front and rear of the panels and is another indication of a too narrow saddle. The uneven pressure along the front of the panels may indicate uneven flocking or uneven shoulder development. The uneven pressure in the flaps may indicate horse or rider imbalances.

McKieran needs a different saddle, one which is wider and conforms better to his conformation. As McKieran is brought further into work and his body changes it would be easier to make adjustments with an Adapatree saddle (www.saddlefit4life.com). More information about saddle fit can also be found at www.Schleese.com.

A full veterinary chiropractic evaluation is also highly recommended to further evaluate the inflammation seen in the spine.
